Darby Creek Watershed Plan

May 2016

Kentucky Waterways Alliance

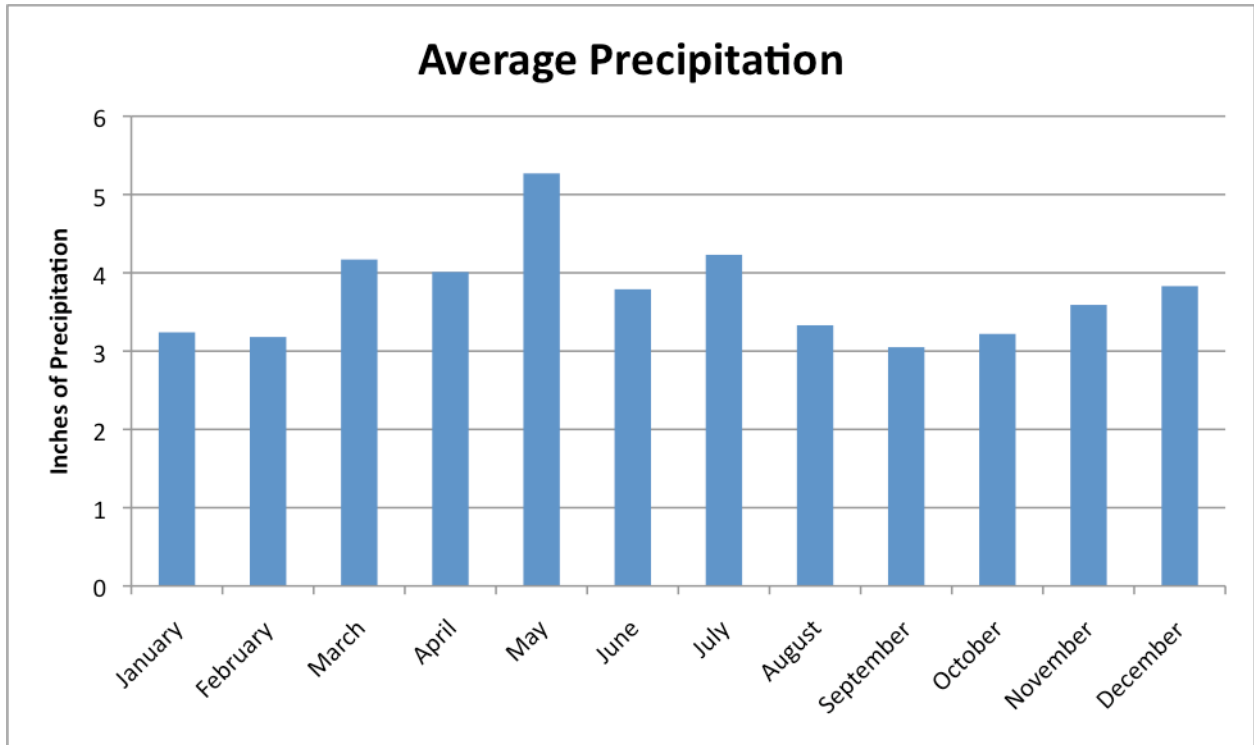
Figure 2.5: Average precipitation from 1981 to 2010 obtained from Louisville area weather stations (SERCC, 2015).

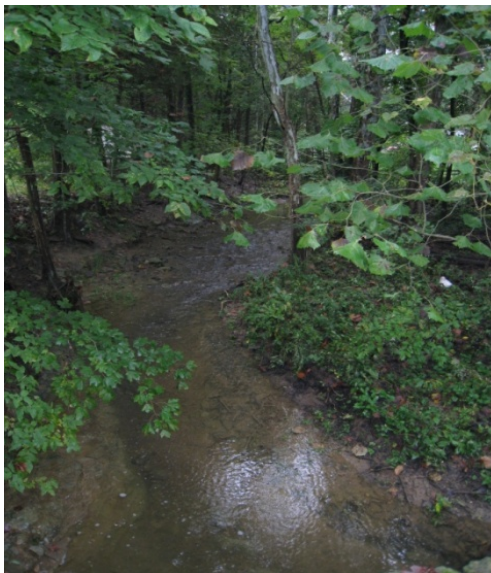
Figure 3.4: UDC2 Reach 4 (Shireman and Gessner, 2009).

- Reach 4 - Grand Villa Drive to headwaters at school complex, scored 8.2 = Good. Comments: Majority of reach was very nice. Upstream portion of stream at school is highly imperviousness and channelized.

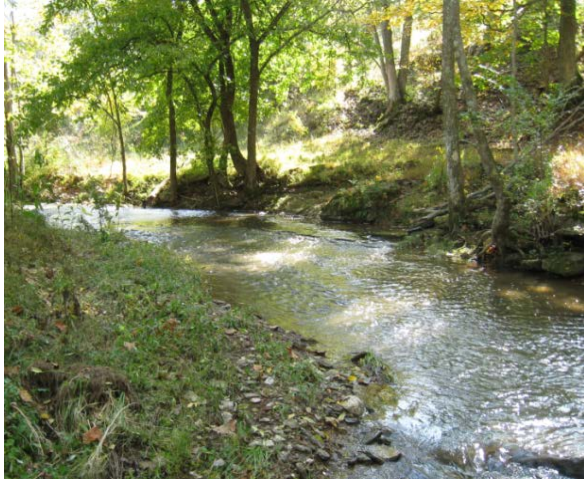
Figure 3.11: DF1 Stream walk Reach 1 (Keibler, 2009).

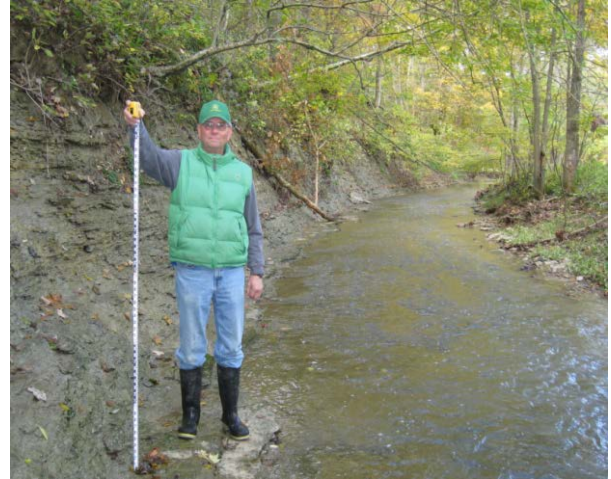
Figure 3.10: DF1 Stream walk Reach 3 (Keibler, 2009).

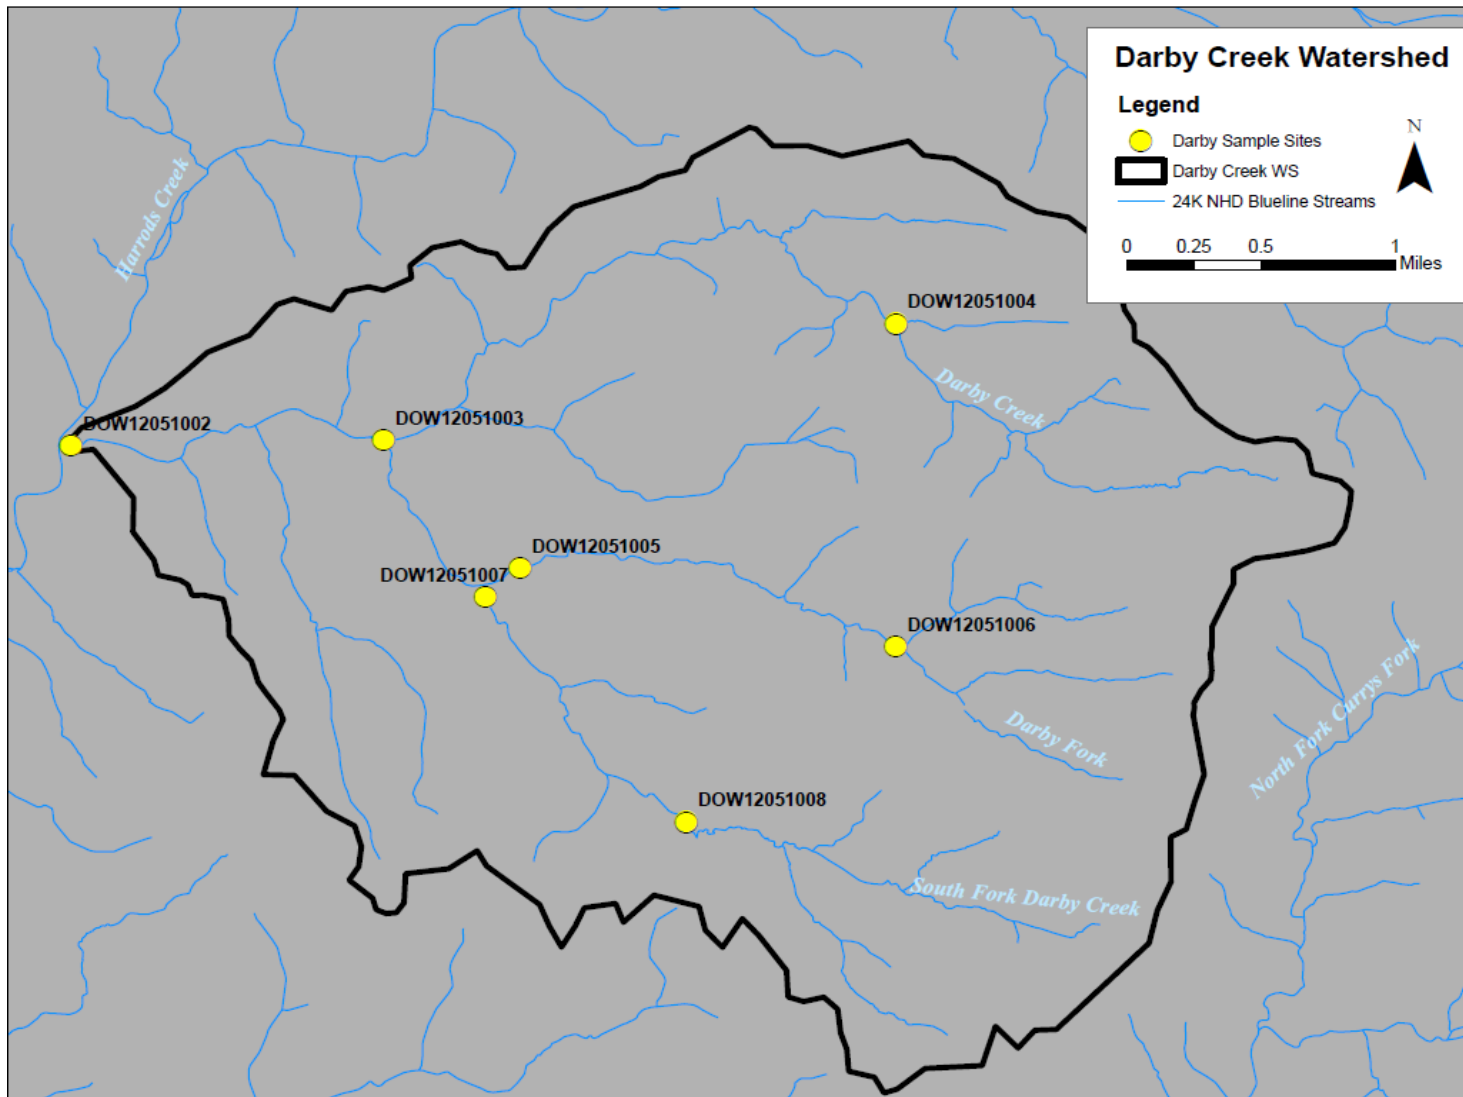
Figure 3.15: KDOW 2014 Sampling Site Locations.

SITE NAME	EDAS #	ORIGINAL #	LAT	LONG	Catchment Area (mi ²)
Darby Creek	DOW12051002	DC1	38.390289	-85.521444	10.48
Darby Creek	DOW12051003	UDC1	38.390565	-85.500000	3.78
Darby Creek	DOW12051004	UDC2	38.397018	-85.464815	1.30
Darby Fork	DOW12051005	DF1	38.383360	-85.490645	2.11
Darby Fork	DOW12051006	*New Site	38.378914	-85.464905	1.20
South Fork Darby Creek	DOW12051007	USF1	38.381763	-85.493056	2.51
South Fork Darby Creek	DOW12051008	USF2	38.369129	-85.479300	1.56

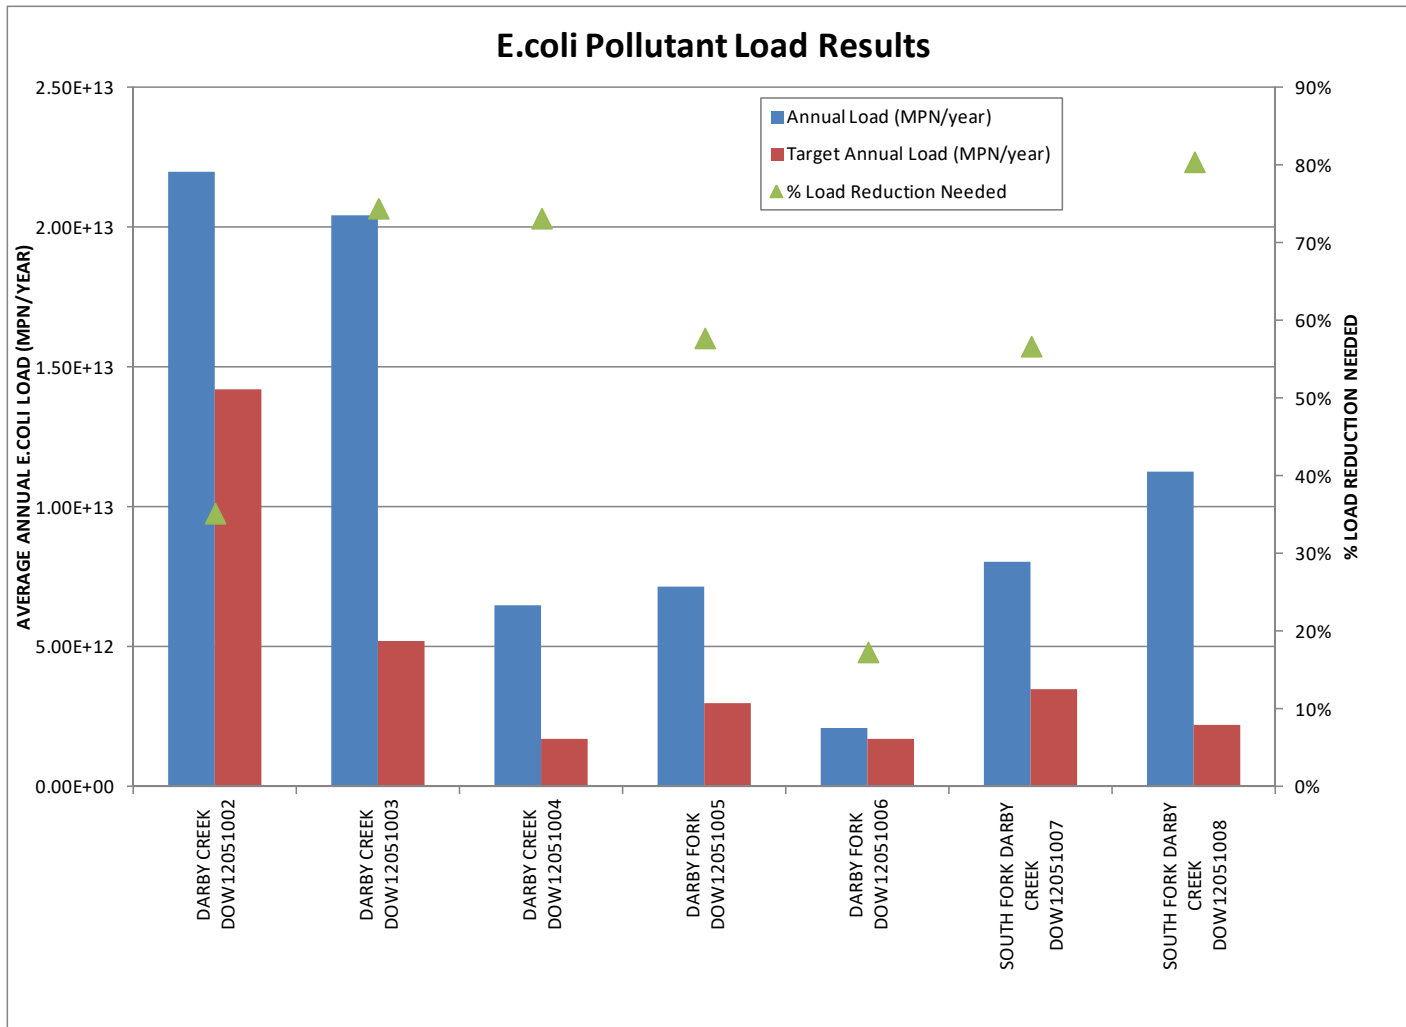
Figure 3.19: *E. coli* Pollutant Load Results from KDOW using Geometric Mean and 130 CFU/100mL PCR Standard.

Site and EDAS number	SITE NAME	Geomean <i>E. coli</i> (MPN/100mL)	MAF (ft ³ /s)	Annual Load (MPN/year)	Target Annual Load (MPN/year)	Load Reduction Needed (MPN/year)	% Load Reduction Needed	Annual Yield (MPN/year/mi ²)
DC1 DOW12051002	Darby Creek	200.70	12.3	2.20E+13	1.42E+13	7.75E+12	35%	2.10E+12
UDC1 DOW12051003	Darby Creek	509.78	4.5	2.04E+13	5.21E+12	1.52E+13	74%	5.41E+12
UDC2 DOW12051004	Darby Creek	485.45	1.5	6.49E+12	1.74E+12	4.75E+12	73%	4.99E+12
DF1 DOW12051005	Darby Fork	308.04	2.6	7.13E+12	3.01E+12	4.12E+12	58%	3.38E+12
New site DOW12051006	Darby Fork	157.32	1.5	2.10E+12	1.74E+12	3.65E+11	17%	1.75E+12
USF1 DOW12051007	South Fork Darby Creek	300.49	3	8.03E+12	3.47E+12	4.56E+12	57%	3.20E+12
USF2 DOW12051008	South Fork Darby Creek	665.91	1.9	1.13E+13	2.20E+12	9.07E+12	80%	7.22E+12
