Dry Creek Watershed Plan

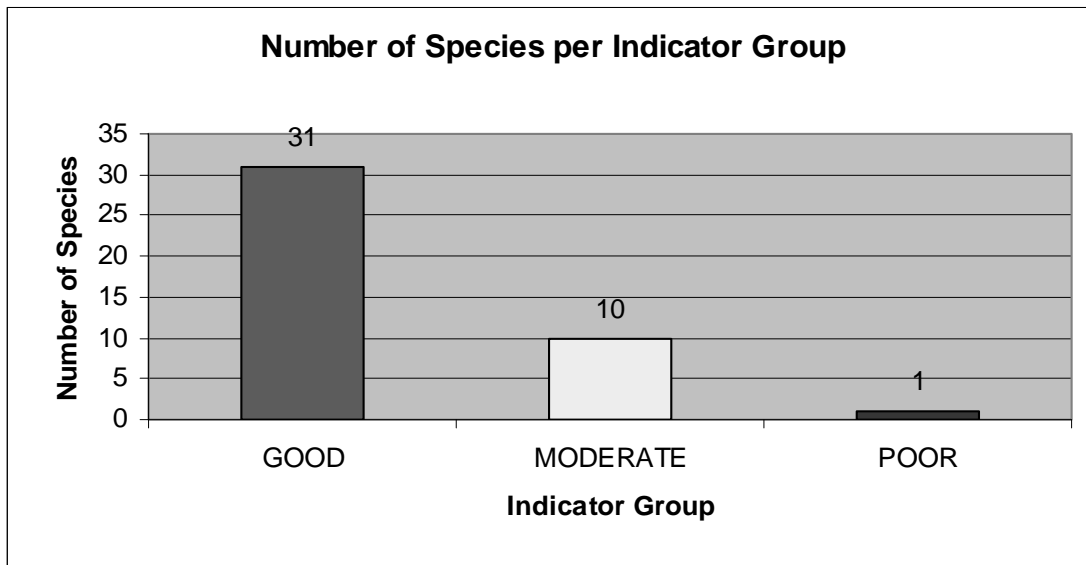
Figure 2.12. Summary of macroinvertebrate data collected in the summer of 2006, by indicator group (data from R. Johnson).

There are limited macroinvertebrate data available for the Dry Creek watershed. One data set was collected in the summer of 2006 just downstream from the HWY 519 Bridge over Dry Creek by a Morehead State University graduate student (R. Johnson) for his M.S. thesis research. Figure 2.12 shows a summary of the number of macroinvertebrate species falling into each indicator group as determined by the Kentucky Water Watch Biological Monitoring Assessment Project. The good indicator group is made up of organisms that are generally pollution-intolerant. The moderate indicator group consists of organisms that can exist in a wide range of water quality conditions. The poor water quality indicator group includes organisms that are generally tolerant of the effects of pollution, such as low dissolved oxygen and excessive sedimentation. The absence of certain macroinvertebrates does not provide information on the source of the pollution, but they are able to provide us with some insight to the extent pollutants are impacting streams.

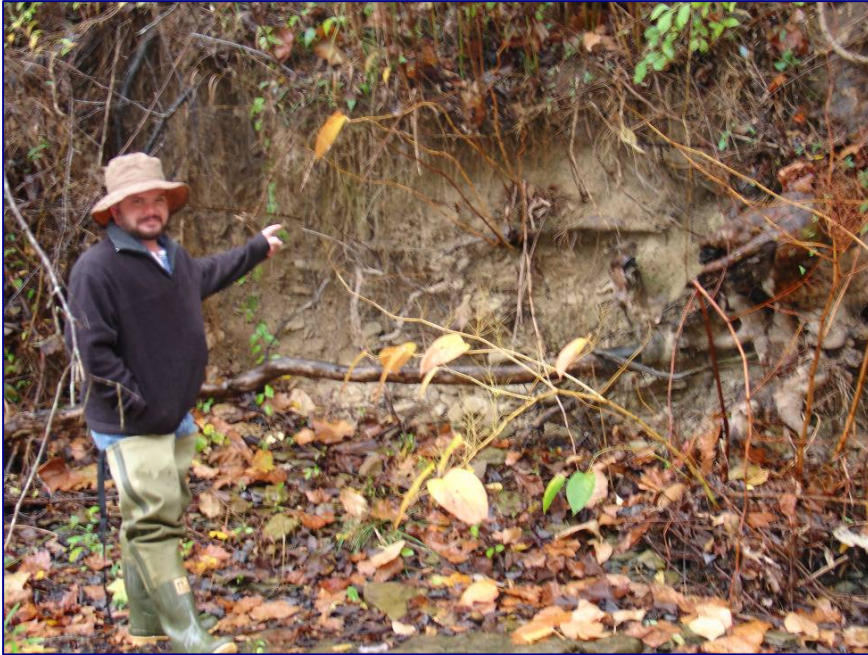
Figure 2.14 Photo showing erosion and mass wasting at a site on Dry Creek.

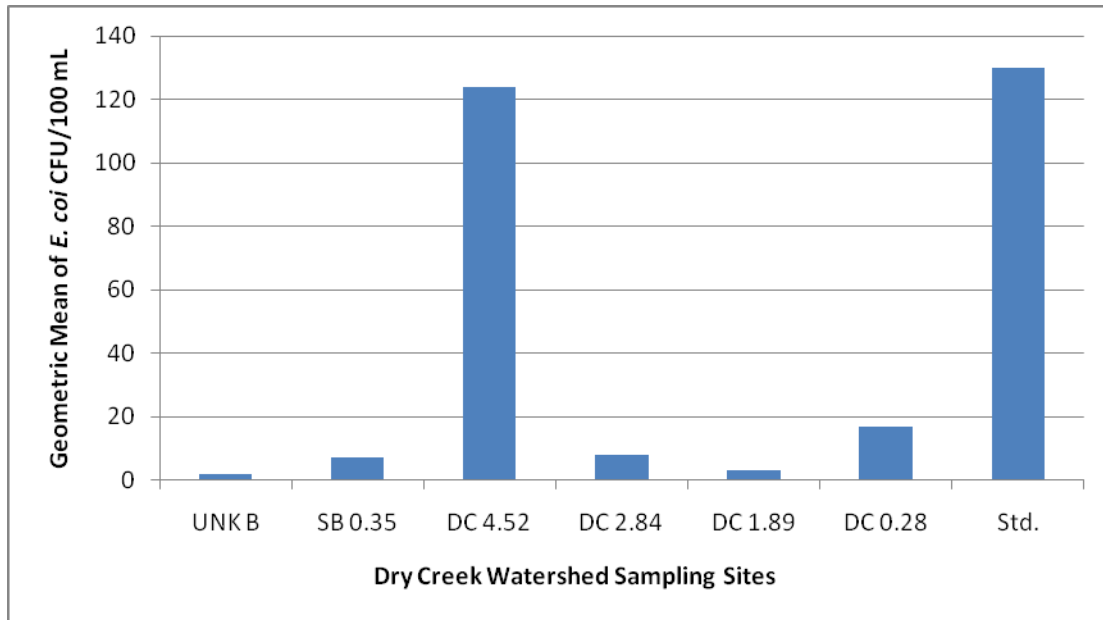
Figure 3.3 Geometric means of *E. coli* counts in the Dry Creek watershed, March-April 2008.

Figures 3.3 and 3.4 show the geometric means of *E. coli* counts for sites in the Dry Creek Watershed for spring and summer 2008.

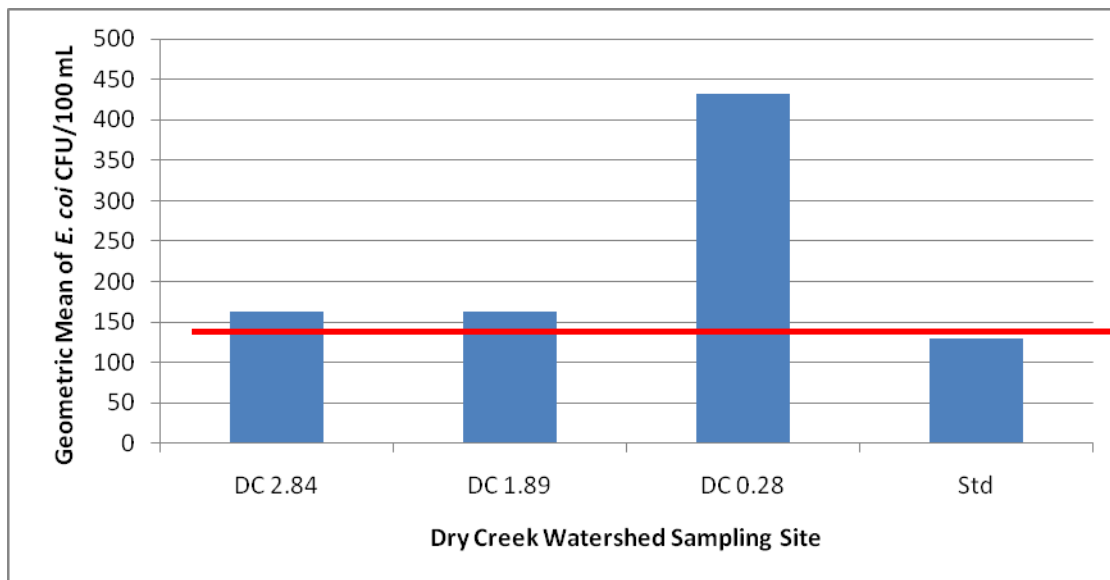
Figure 3.4. Geometric means of *E. coli* counts in the Dry Creek Watershed, August-September 2008. The red bar indicates the KDOW limit of 130 *E. coli*/100 mL.

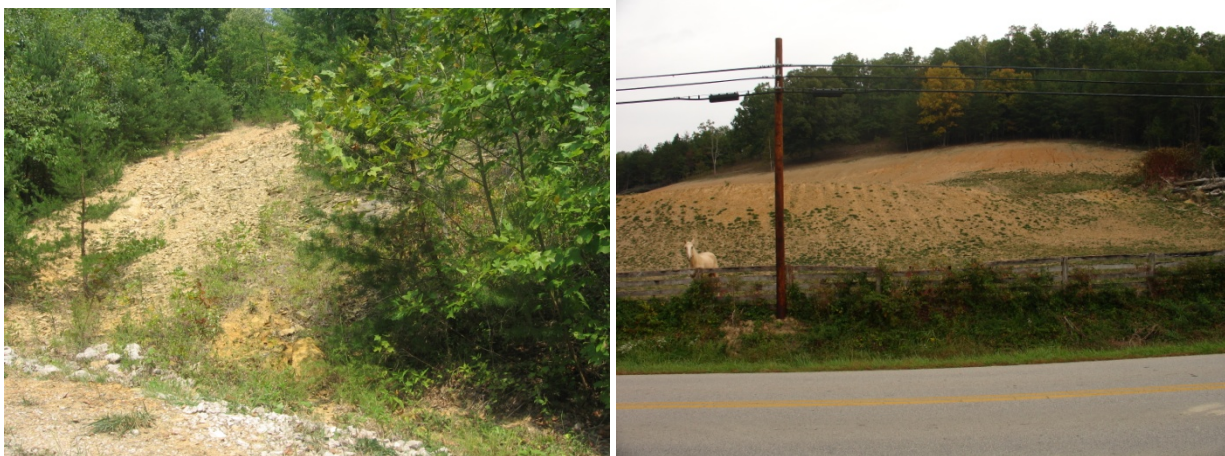
Figure 3.5. Example of vegetative cover being removed and not replanted.

As discussed in Chapter 2, various land use practices negatively impact the water quality of Dry Creek and its tributaries. An EPA Watershed Inventory Form, which was downloaded from the EPA Watershed web site, was used to conduct a visual watershed inventory for the Dry Creek Watershed. Results of this inventory identify the presence of 10 bridges, 15 drain pipes, 7 drainage ditches, 1 storm drain, 3 vehicle crossings, and 4 natural gas pipeline crossings on Dry Creek. Approximately 1 mile of 5.8 miles of Dry Creek has been straightened. In addition, there are signs of ATV use along and in Dry Creek for short sections as well as obvious use of equipment (e.g., Bobcats or front-end loaders) to move large quantities of gravel. The alterations described above do not include Dry Creek tributaries, only Dry Creek itself. Figures 3.5 through 9 show examples of commonly observed, poor land use practices.

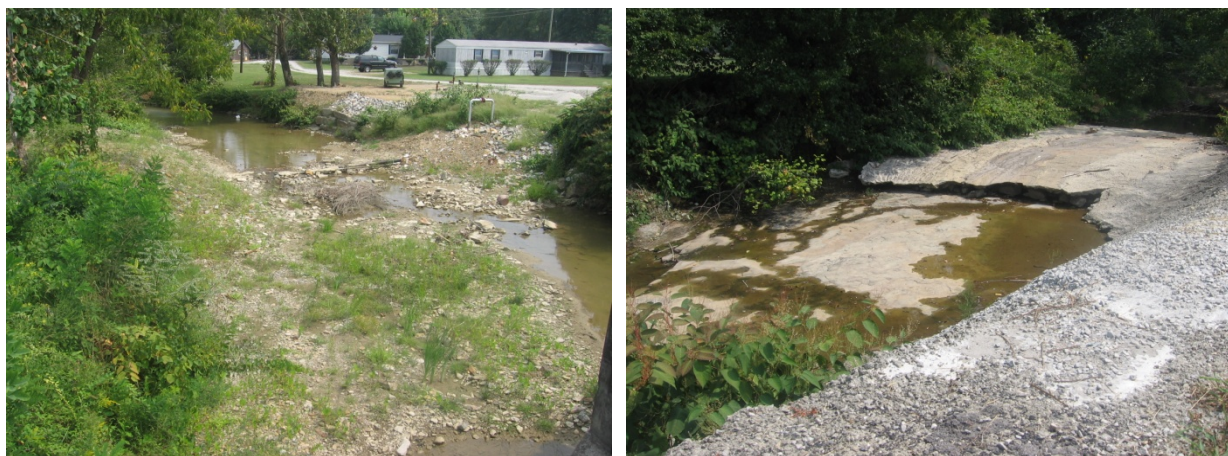
Figure 3.6. Examples of pipeline crossings on Dry Creek.

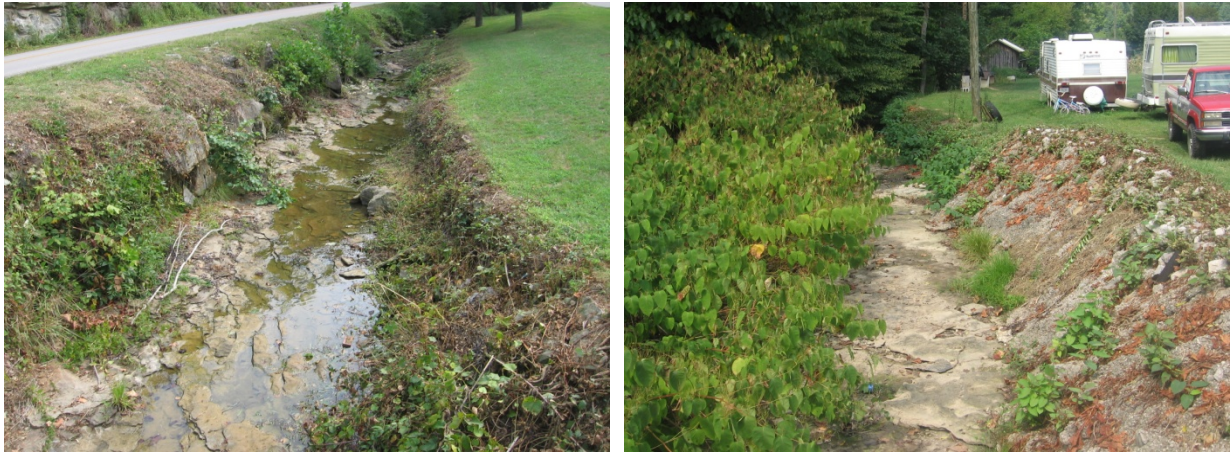
Figure 3.7. Examples of stream straightening and private bank armoring.

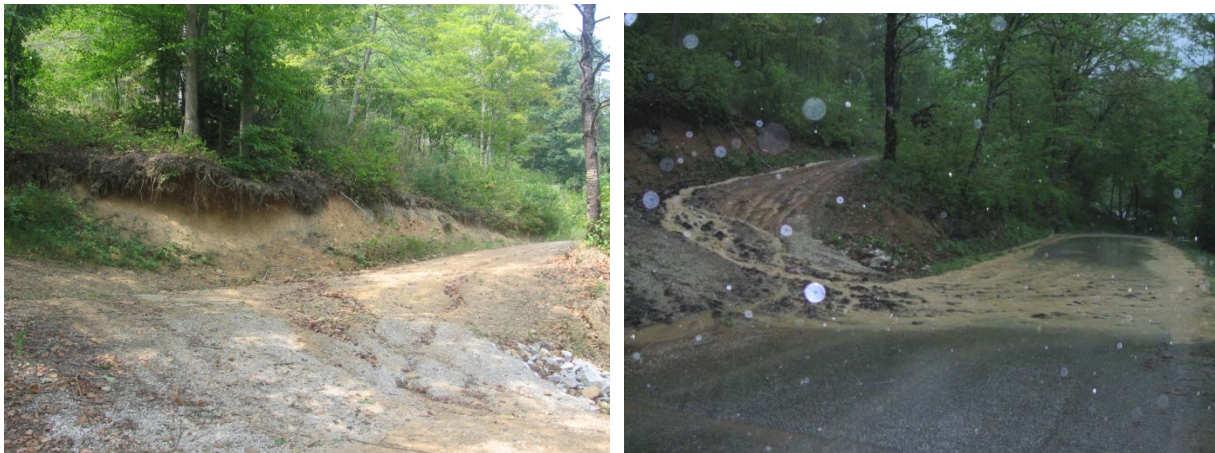
Figure 3.8. An example of poor land use. The photo on the left is a road cut into a hillside. Note the overhanging, eroded bank and gullied road. The photo on the right is the same site during moderate rainfall.

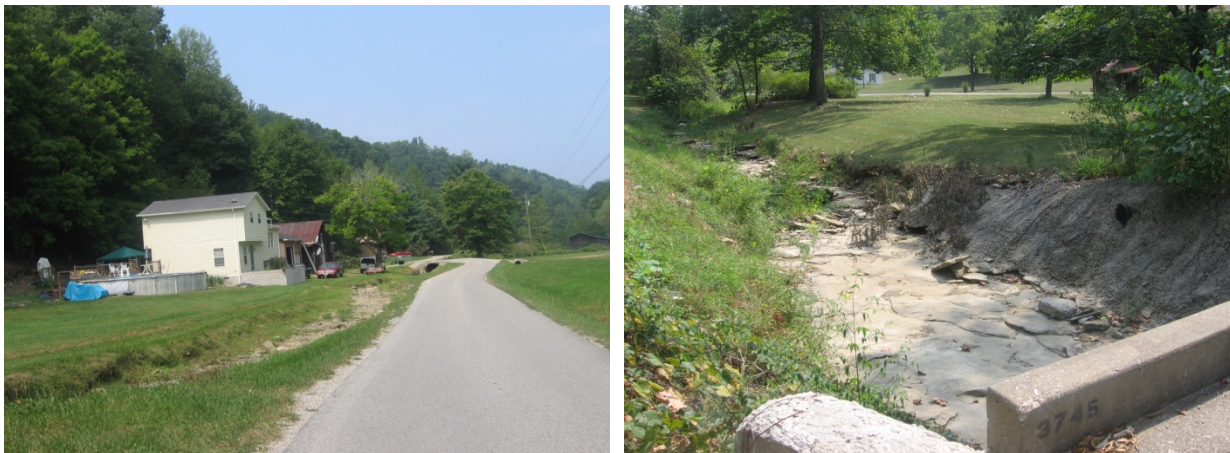
Figure 3.9. Removal of trees from riparian zones (left) and channelization/bank armoring (right).

Habitat quality varies widely throughout the watershed (Table 3.18). Riparian zones have been extensively altered. Trees have been removed from one side and, in many cases, both sides of streams. The best score for the sites investigated was 126 (DC-0.28, Figure 3.10) and the worst score was 51 (SB-0.35, Figure 3.9).

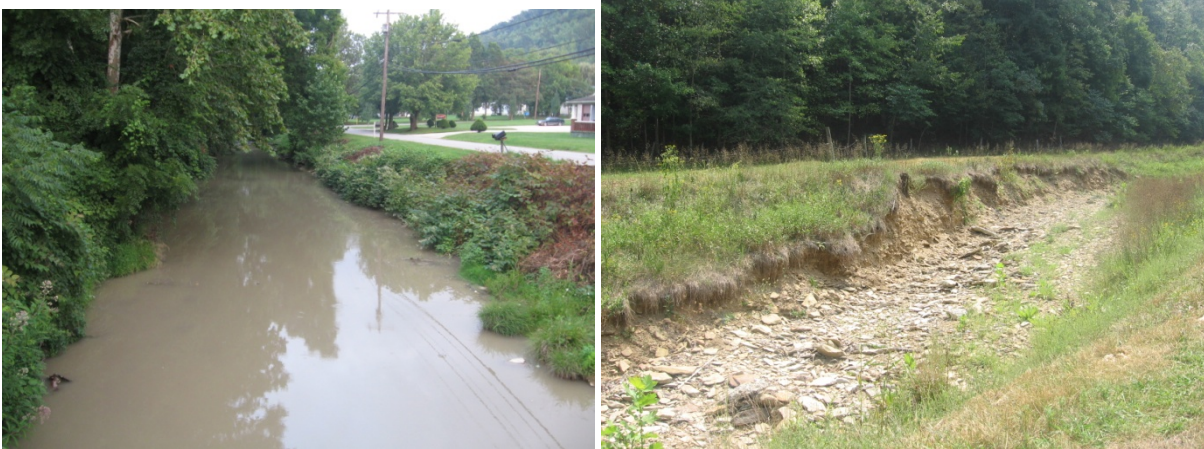
Figure 3.10. Photos of sites with best (DC-0.28, left) and worst habitat scores (SB-0.35, right).

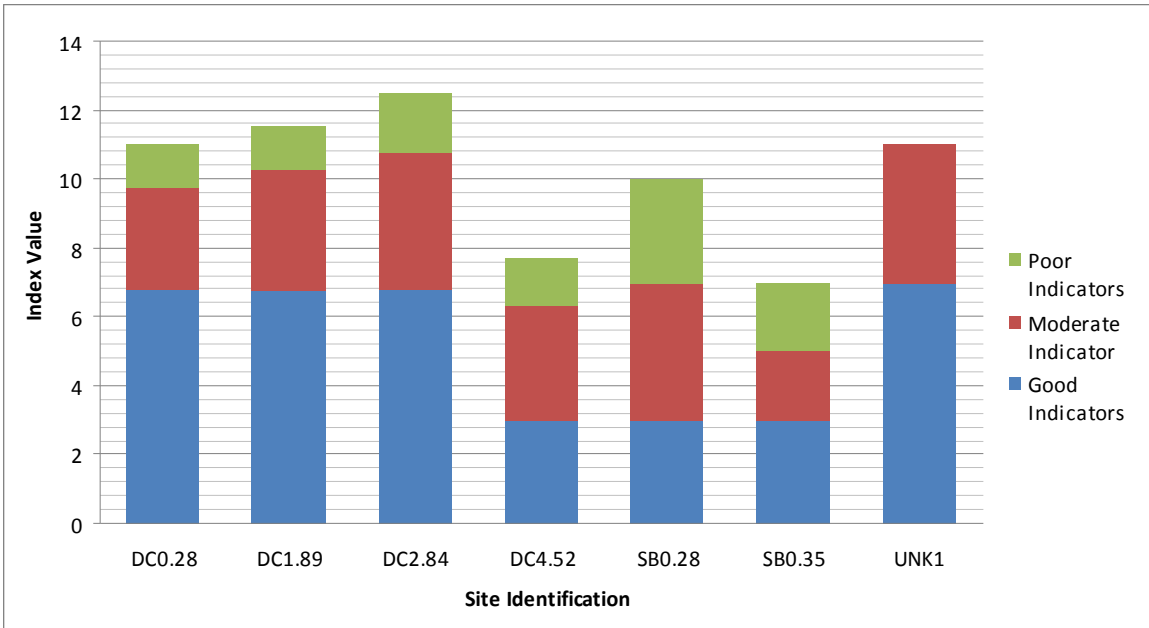
Figure 3.11. A summary by site of the average index value for each taxa group.

The good water quality indicator species increased in locations where water was present all year. A predominance of positive water quality indicators was present at UNKA. This site does not have houses upstream and is mostly wooded. At site SB-0.28, aquatic worms were often observed in large quantities, which accounts for the high amount of Group 3 (bad) indicators.

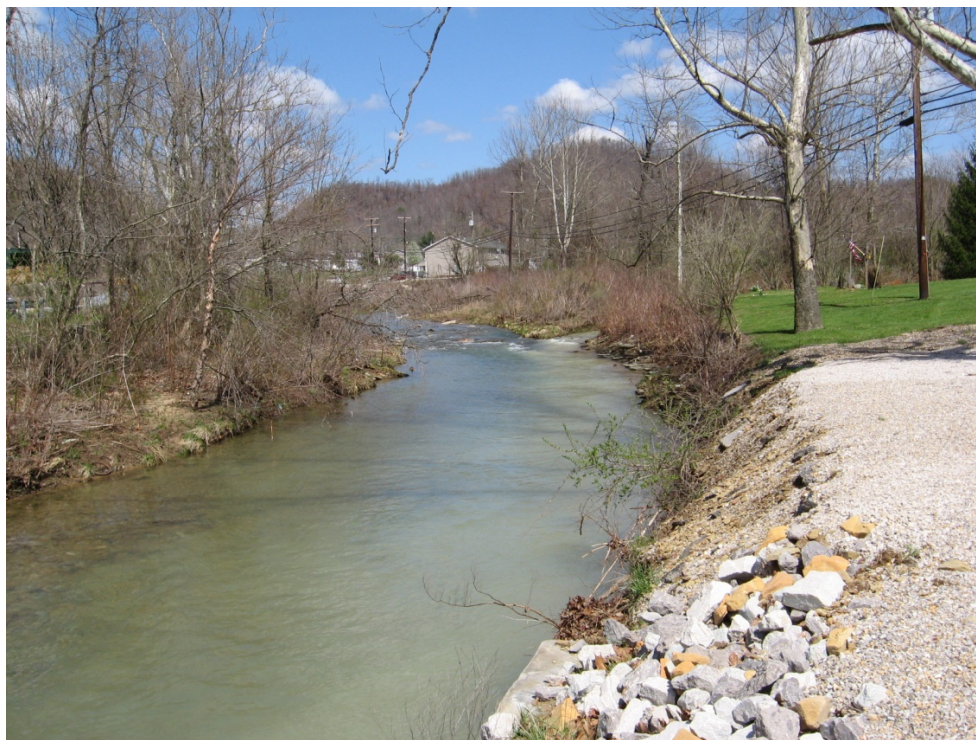
Figure 3.13: View of Morgan Fork and Dry Creek confluence looking upstream from near KY 519 bridge. Note high suspended sediment load (cloudy water) coming from Morgan Fork on the right side of Dry Creek.

Sediment influx into the lowest reaches of Dry Creek (near DC-0.28) during the monitoring period was extreme due to construction on KY 519. Extreme SSC and suspended sediment loads from Morgan Fork (Figure 3.13) dramatically affected data at DC-0.28 (Tables 3.13 and 3.14). The ultimate cause of the very high SSC, loads, and yields from Morgan Fork and the lowest reaches of Dry Creek were complete denudation of vegetative cover and the use of heavy machinery in and near the streams. But the problem was much worse than it should have been because contractors did not install erosion prevention and sediment controls during most of the construction project (Figure 3.14). A few erosion prevention and sediment controls appeared after a resident of the Dry Creek watershed complained to the local Kentucky Division of Water office.

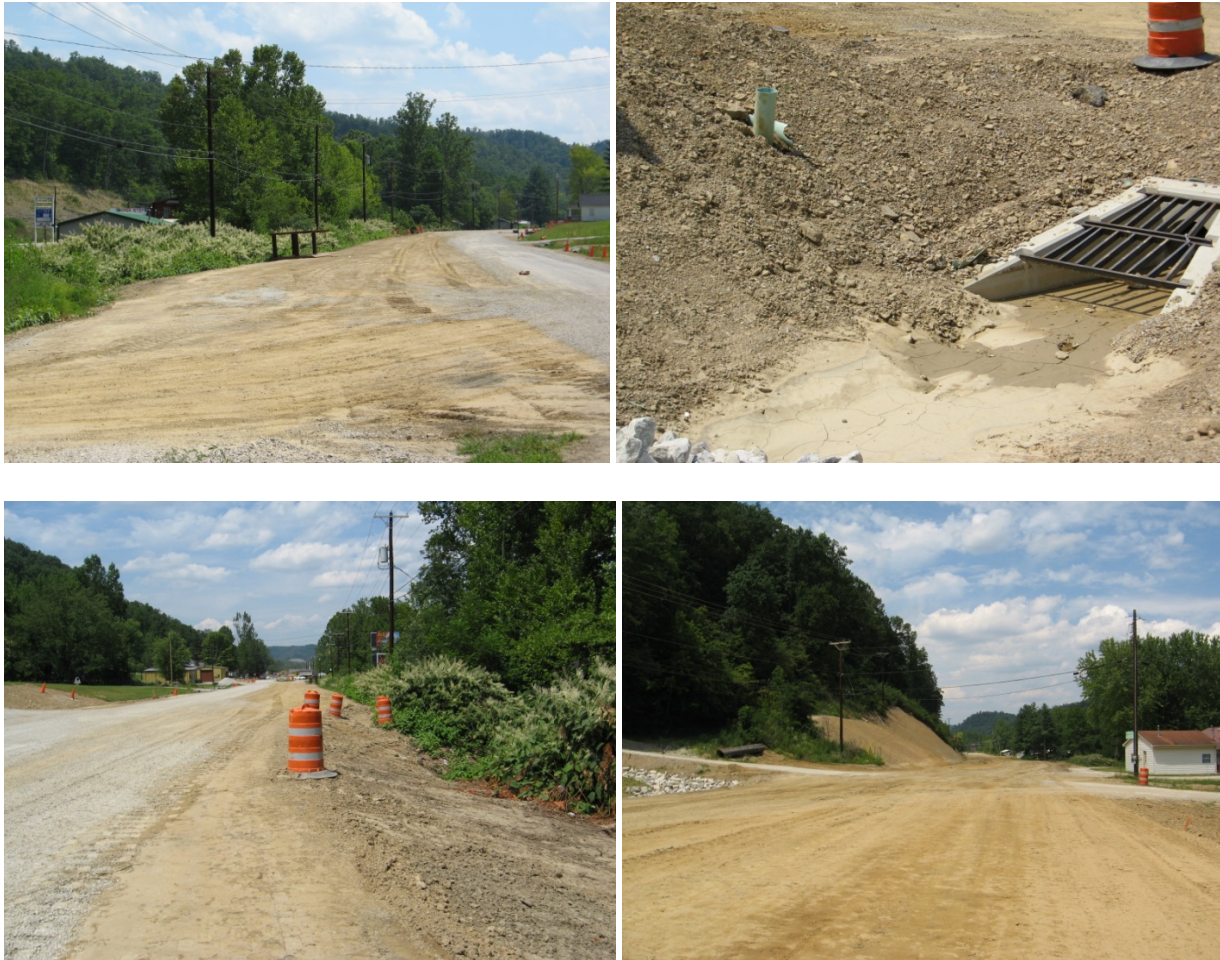
Figure 3.14: Sample of images taken during KY 519 construction, which show a complete absence of the erosion prevention and sediment controls required by state contracts.

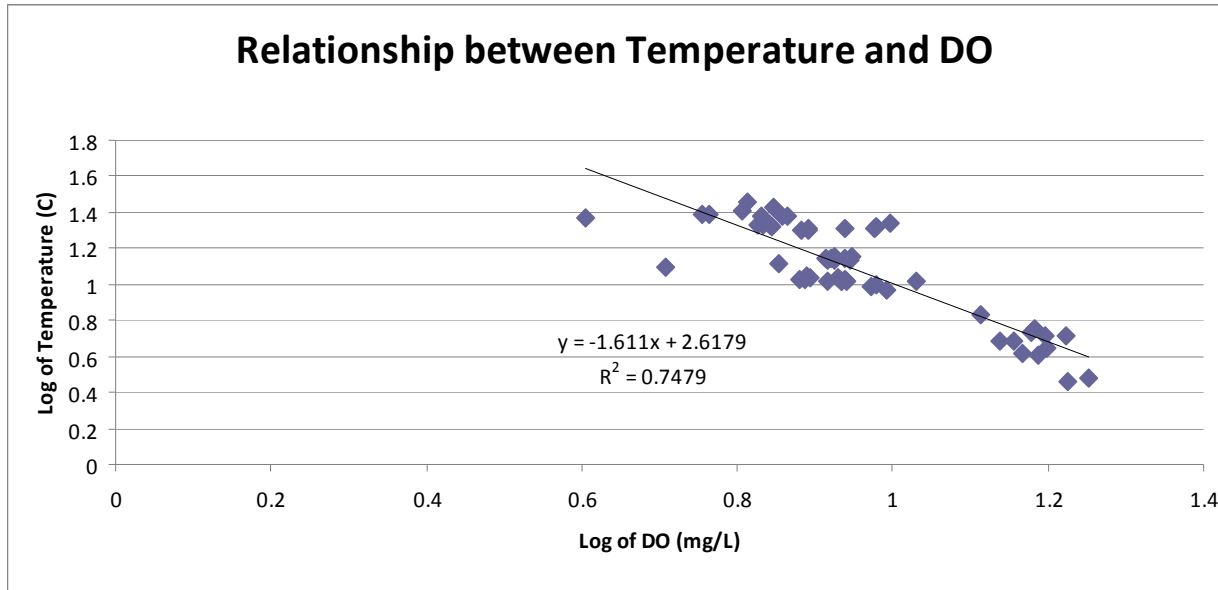
Figure 3.15. Relationship between temperature and DO (mg/L).

Poor habitat quality is the number one impact on temperature and DO. Although there are many parameters that can impact DO, only temperature showed a negative relationship to DO levels (Figure 3.15). Temperature increases are likely the result of tree removal. Another possible source of high water temperature is runoff from pavement since roads exist along most of Dry Creek and along major tributaries. In addition to temperature, low water velocity also contributed to excessive DO loss, again due to habitat destruction.

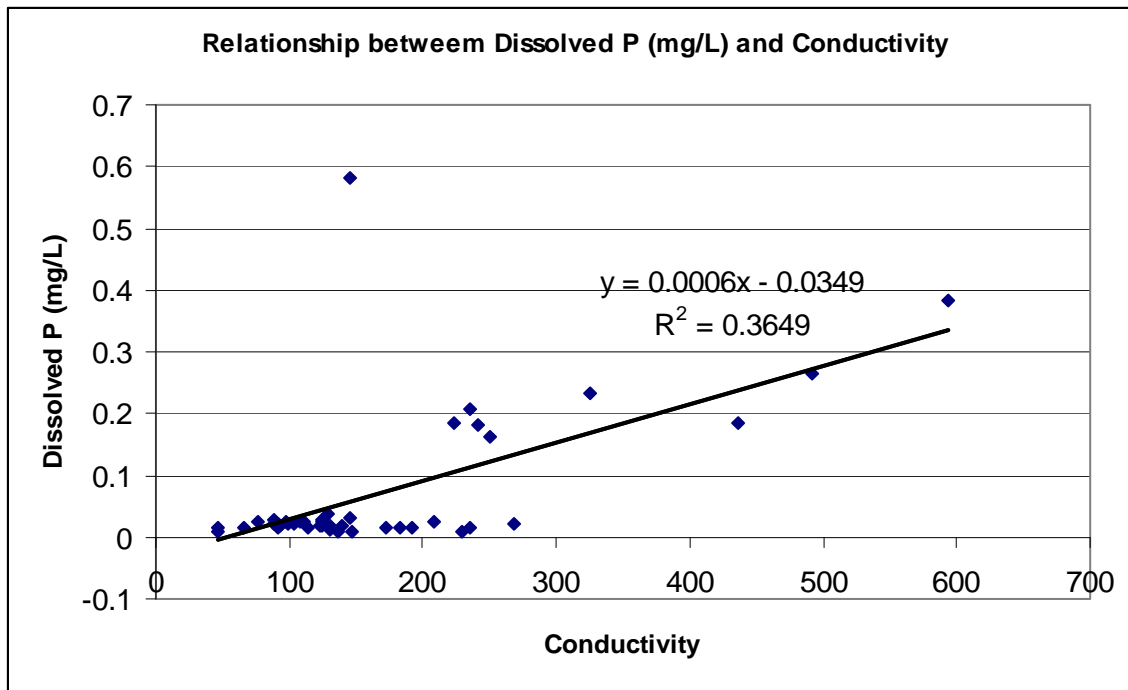
Figure 3.16 Relationships between nutrients and conductivity.

approach was used to explore possible relationships between pH, nutrients, conductivity, temperature, and DO but none were significant.

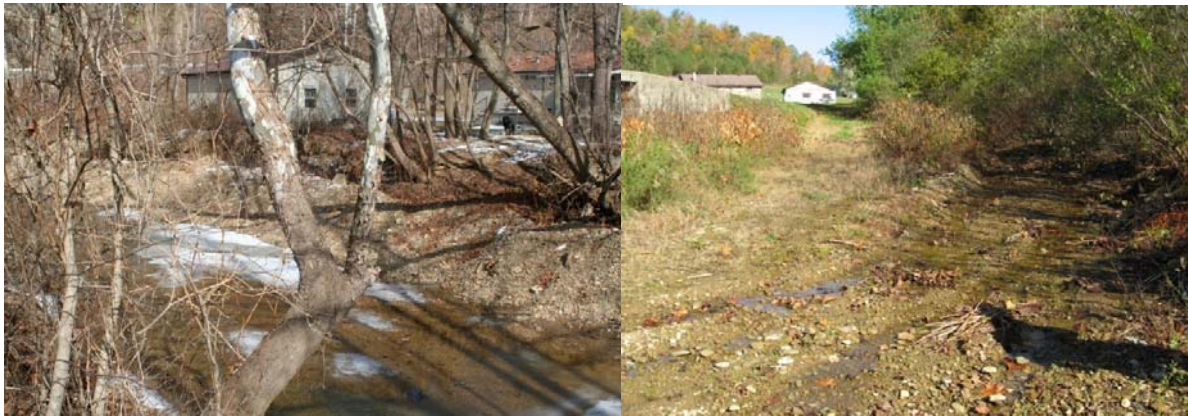
Figure 3.17: Gravel mining in Dry Creek. In left image, gravel has been scraped down to bedrock and piled against the bank as a form of armoring. Note leaning and curved trees caused by bank erosion and undercutting. Right image shows access road to streambed and obvious signs of gravel mining, including tire tracks leading from the streambed to this loading area.

Channel alteration and gravel mining have and probably will continue to cause a variety of problems in the watershed. Habitat destruction is obvious based on assessments conducted for this study. Complete removal of gravel bars near pools and riffles has eliminated spawning areas from many parts of Dry Creek. The rapid appearance of “new” gravel due to colluvium and bedrock erosion (Figures D2 and D3, Appendix C) virtually assures that disruptive gravel mining will continue. All of these practices tend to increase flow velocity and accelerate down-cutting and bank erosion. Channel entrenchment is likely to worsen in the future.

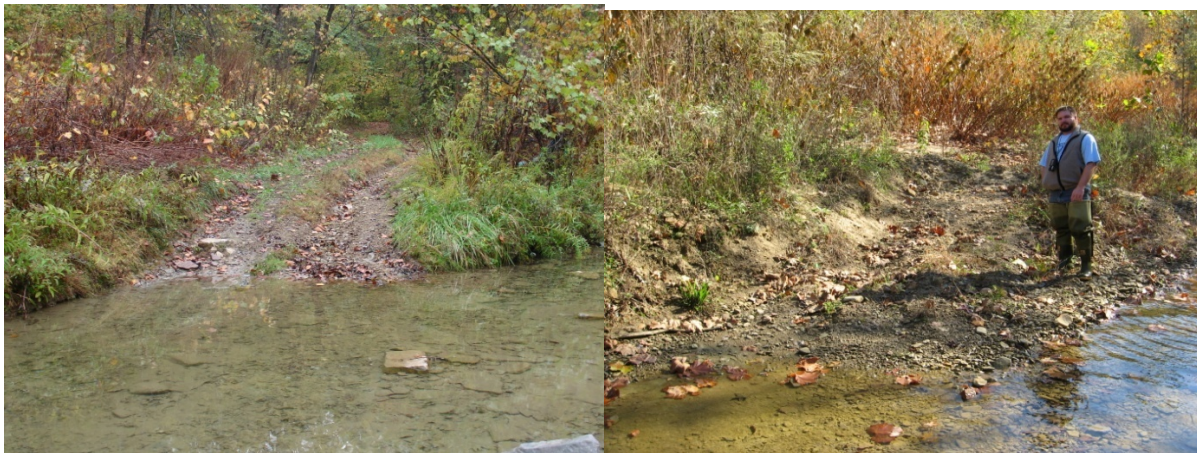
Figure 3.18: More unimproved access roads to Dry Creek streambed. Note fine-grained sediment deposited on the channel bottom, an example of impairment due to sedimentation/siltation. Most of the gravel has been removed in both images.

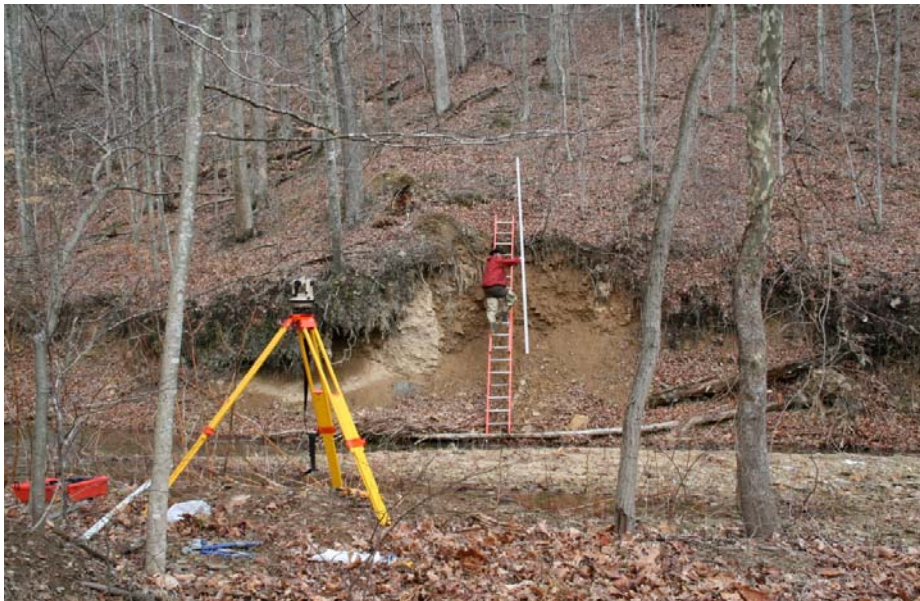
Figure D1: Monitored channel cross-section (SB-0.23a) within 170 ft reach just downstream of SB-0.23 where Sugar Branch erodes colluvium at the base of a steep slope.

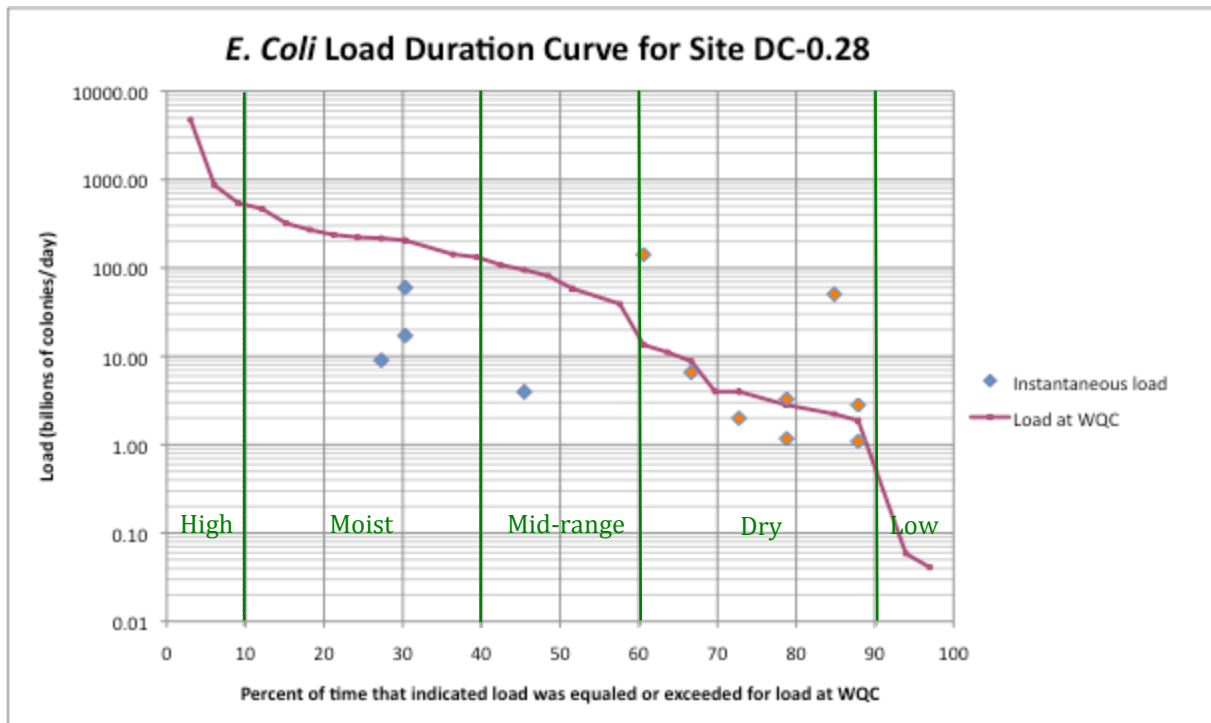
Figure D4: Load duration curve for DC-0.28 (Tile Storage Road Bridge). Orange diamonds are instantaneous loads for samples collected during the recreation season.

In addition to the geometric mean data for *E. coli* discussed in Chapter 3, MSU biologists collected intermittent *E. coli* samples throughout the year. Here, all samples are considered individually, even those collected to calculate geometric means. Therefore, a WQC for primary contact recreation of 240 colonies/100 mL was converted to billions of colonies/day and used to

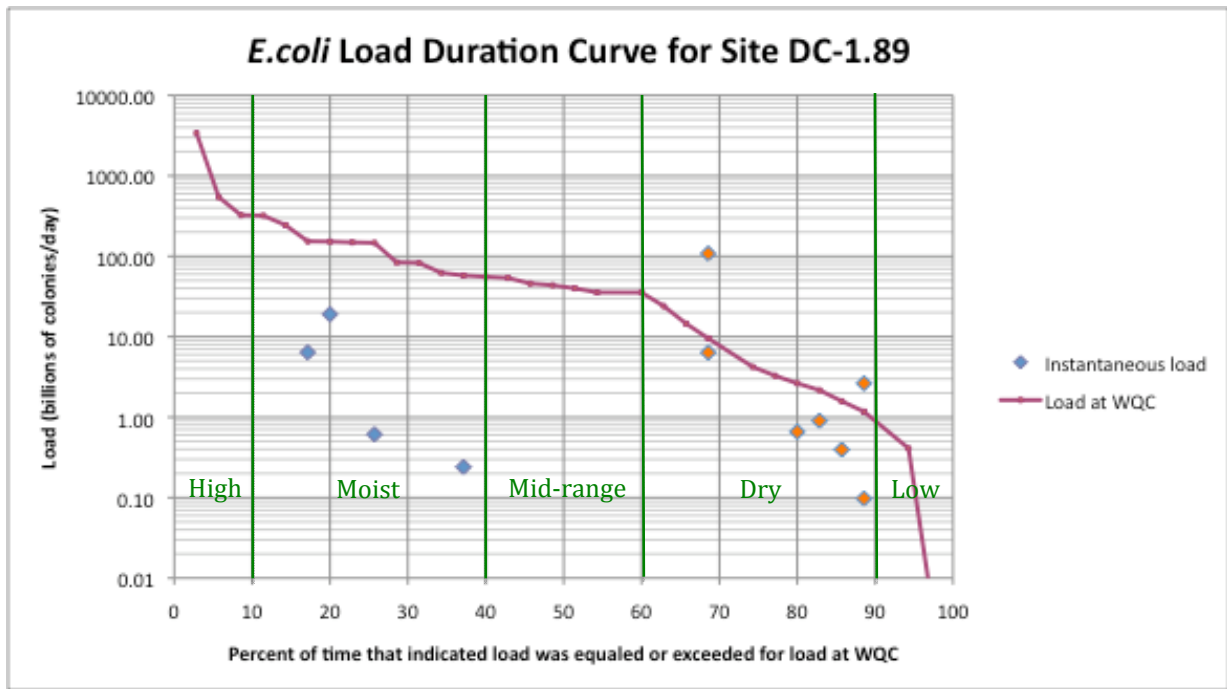
Figure D5: Load duration curve for DC-1.89 (Ravenswood Road Bridge). Orange diamonds are instantaneous loads for samples collected during the recreation season.
