Stockton Creek Watershed Plan

Stockton Creek/Town Branch Watershed Plan

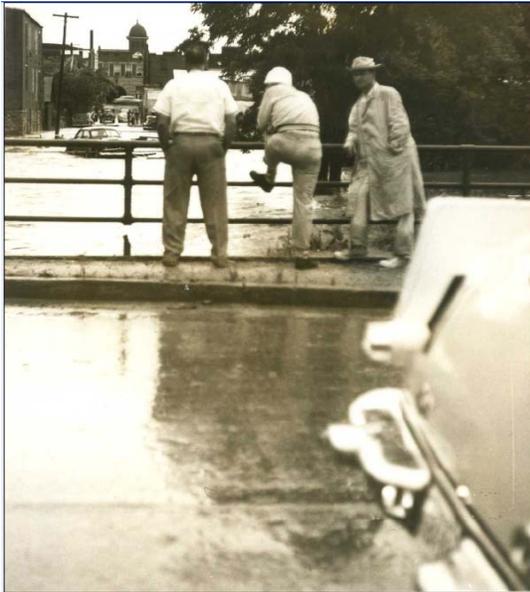
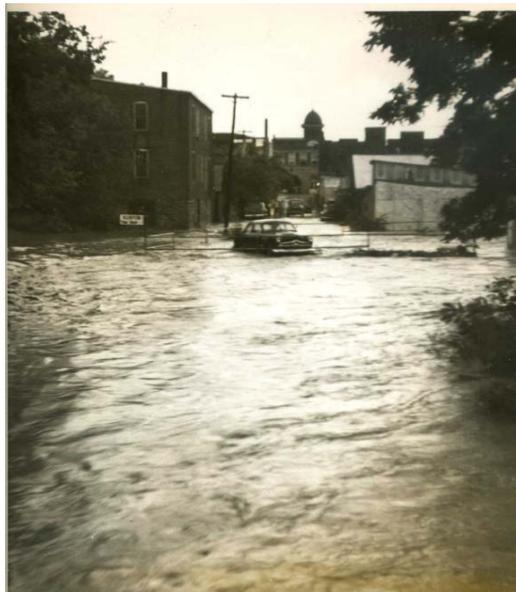
Figures 2.4 and 2.5 Photos from the 1956 flood in Flemingsburg (Flemingsburg Gazette, 1956).

Flooding is a natural phenomenon that occurs regularly with any waterway. Flooding can be worse if an area has a lot of land surfaces that don't allow water to sink in or infiltrate back into the soil (“impervious surface”) like a parking lot. This is because there is more water from a rain or snow event running off to the lowest point of town instead of infiltrating. The downtown area of Flemingsburg proper experiences flooding during large rainfall events, especially below Main Cross where the businesses and roads are built over the stream (see Figure 2.6). A healthy riparian zone and an undeveloped floodplain can help decrease the severity of flooding. As an area becomes more developed with more impervious surfaces, the more frequent severe

flooding may be. Stream channel modification and filling in of the floodplain are factors that contribute to more frequent and severe flooding.
